# Manhole Inspection Summary

Manhole # S17A1\_006MH

Insp Date: **6/13/08 11:10 AM**

**Location** Address: **1908 wilmington av**

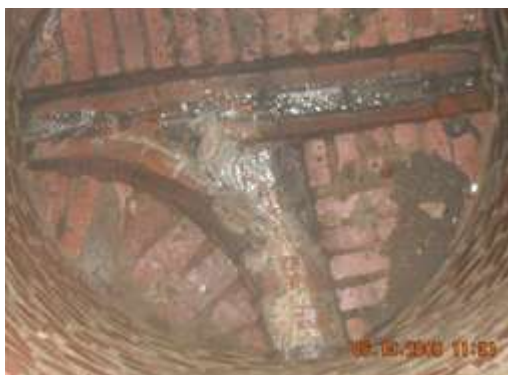
Defect 3

Condition: ☐ Sound ☐ Cracked ☐ Root Intrusion ☐ Deteriorated ☐ Leaks ☒ **Debris**

debris in channel

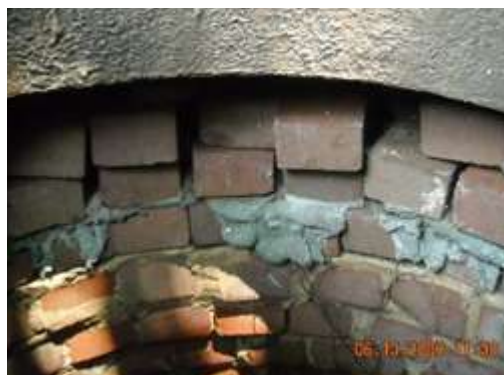
Defect 2

Condition: ☐ Sound ☐ Cracked ☐ Root Intrusion ☒ **Loose Brick** ☐ Deteriorated

loose chimney bricks

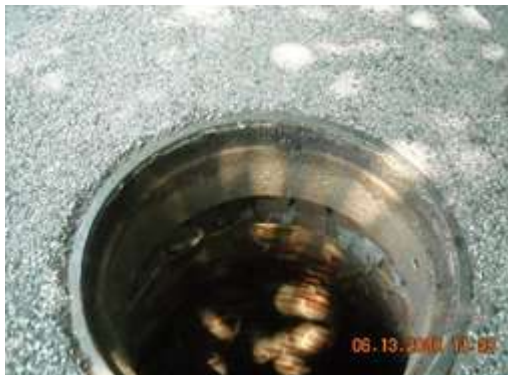
### Defect 1

Subject To Ponding: **Sheeting**

☒ **Leaks**

inflow evidence from sheeting
